Manhole Inspection Summary

Manhole # S35GG_001MH

Insp Date: **3/14/07 11:36 AM**

Location Address: **1501 LATROBE ST**

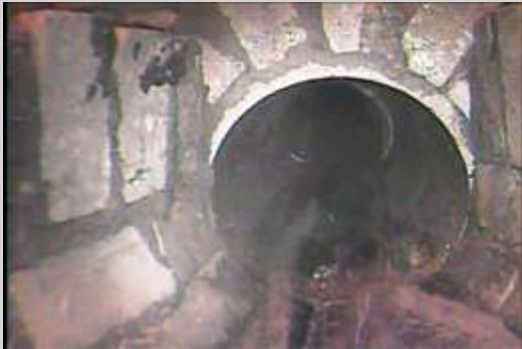
8 in. Circular Gravity Sewer Pipe Out @ 12 O'Clock

Rod and Bar (Angled)

Pipe Material: **Clay** ☐ Pipe Lined

Infiltration: **None** Pipe Seal Cond: **Unknown**
